**NC-Choice Home Inspection Service  
4619 NC Highway 150 E  
PO Box 551 (invoice-billing)  
Browns Summit, NC 27214  
(336) 656-4821 Office/fax  
(336-558-5319) cell**

Doc #: 1110-1994

Dwelling Address: 1234 Hope St  
Any town, NC 27000

Client Name: James & Mary Smith

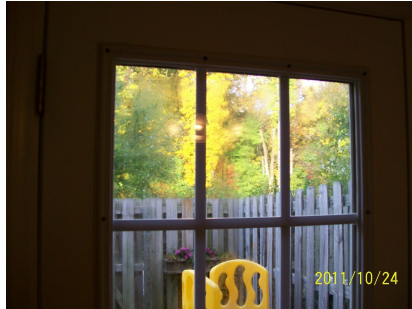
2305. Windows Recommendation. Condensation or haze was noted in the double insulated window pane at rear entry door. This indicates a broken seal that can reduce the visibility and insulating capability of the window. To restore visibility and regain insulating capability, replacement of this window/pane is required. Recommend maintenance/repair by a Licensed General Contractor.

Step #	Component	Comments
2301	Floor	Serviceable. Wood.
2302	Walls	Serviceable. Painted
2303	Ceiling	Serviceable.
2304	Doors	Serviceable.
2305	Windows	Recommendation. Condensation or haze was noted in the double insulated window pane at rear entry door. This indicates a broken seal that can reduce the visibility and insulating capability of the window. To restore visibility and regain insulating capability, replacement of this window/pane is required. Recommend maintenance/repair by a Licensed General Contractor.
2306	Electrical	Serviceable. Ground fault circuit interrupter (GFCI) noted.
2307	Heat Source	Serviceable. Forced air register observed.
2308	Counter Tops	Serviceable. Laminate
2309	Cabinets	Serviceable.
2310	Sinks	Serviceable.
2311	Faucets	Serviceable.
2312	Traps/Drain System	Serviceable.

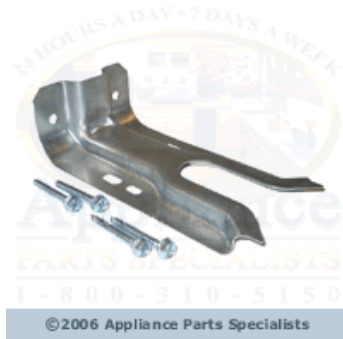
2315. Stove/Cook Top/Oven Recommendation. Electric. Unit is not secured with an anti-tip bracket. Anti-tip bracket may not have been required when stove was installed. Recommend installing for safety. Recommend maintenance/repair by a qualified specialist.

2313	Disposal	Serviceable. Appliance Brand: badger.
2314	Dishwasher	Serviceable. Appliance Brand: Kenmore. Dishwasher was tested using normal operating controls. Unit functioned properly at time of inspection. Dishwashers most commonly fail internally at the pump, motor or seals. These units are not disassembled to inspect these components nor are they visible or accessible to the inspector. Our inspection is limited to operating the unit on the 'normal wash' cycle only.
2315	Stove/Cook Top/Oven	Recommendation. Electric. The electrical stove/range elements were tested at the time of inspection and appeared to function properly. These can fail at any time without notice. No warranty, guarantee or certification is given as to future failure. Unit is not secured with an anti-tip bracket. Anti-tip bracket may not have been required when stove was installed. Recommend installing for safety. Recommend maintenance/repair by a qualified specialist.

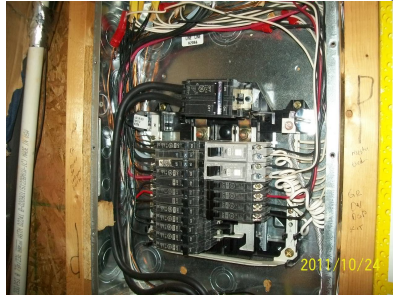
2101 Electrical Main Box Serviceable. The main panel is located at utility room. The main electrical service is approximately 125 amps and 220 volts. Service entrance is underground. Overload protection is provided by breakers. Main disconnect noted. Main conductor is aluminum. Low amperage (15 & 20 amp) branch circuit conductor is copper. Visible wiring type is non metallic sheathed. Evidence suggests system is properly grounded.
